**ASBESTOS REINSPECTION SURVEY  
OF  
SOLIHULL MAGISTRATES COURT, THE COURT HOUSE, HOMER ROAD, SOLIHULL, B91  
3RD**

**CLIENT: G4S FACILITIES MANAGEMENT (UK) LTD (MOJ TFM)  
CARLTON HOUSE, CARLTON ROAD, WORKSOP, NOTTINGHAMSHIRE, S81 7QF**

**UPRN NO: FJ307  
PROJECT NO: J266917  
DATE: AUGUST 2015**

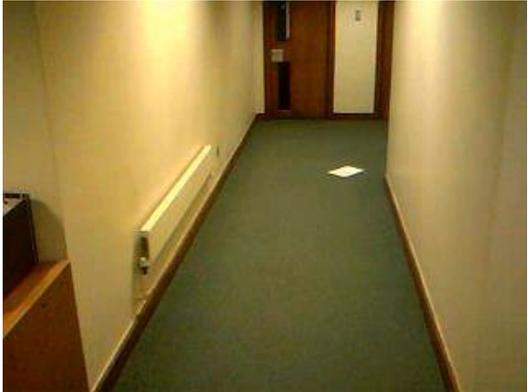
Main activity	Periodic	2

Secondary activity	Periodic	2	
Location	Large Rooms	1	
Extent	<10m <sup>2</sup> and <50m <sup>2</sup> or >10m linear and <50m linear	2	
Accessibility	Occasionally	1	
Occupants	>10	3	
Occupant Hrs	>1 to <3hrs	1	
Occupant frequency	Daily	3	
Maintenance disturbance	Low dist.	1	
Maintenance frequency	<= 1 year	1	
<b>Total Priority Score</b>		<b>6</b>	
Floor / Room	Z-Sub Level 1 002 CORRIDOR		
Description	Brown floor tiles and bitumen adhesive beneath carpet		
Recommendation	Monitor condition and remove if works will disturb		
Sample number	Identified IR005 {AK000184}***		
Sample result	Chrysotile		
<b>Material Assessment Score</b>	<b>3</b>	<b>Risk Level</b>	<b>Low</b>

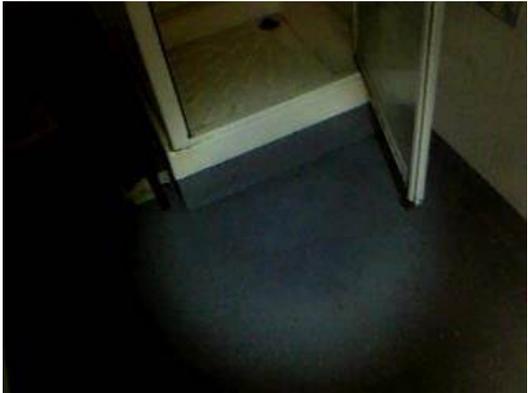
Main activity	Low	1

Secondary activity	Low	1	
Location	Large Rooms	1	
Extent	<10m <sup>2</sup> or < 10m linear	1	
Accessibility	Occasionally	1	
Occupants	4 to 10	2	
Occupant Hrs	>1 to <3hrs	1	
Occupant frequency	Daily	3	
Maintenance disturbance	Low dist.	1	
Maintenance frequency	<= 1 year	1	
<b>Total Priority Score</b>		<b>5</b>	
Floor / Room	Z-Sub Level 1 003 CHANGING ROOM		
Description	Bitumen adhesive beneath vinyl flooring (tiles removed)		
Recommendation	Monitor condition and remove if works will disturb		
Sample number	Identified IR013 {AK000187}***		
Sample result	Chrysotile		
<b>Material Assessment Score</b>	<b>3</b>	<b>Risk Level</b>	<b>Low</b>

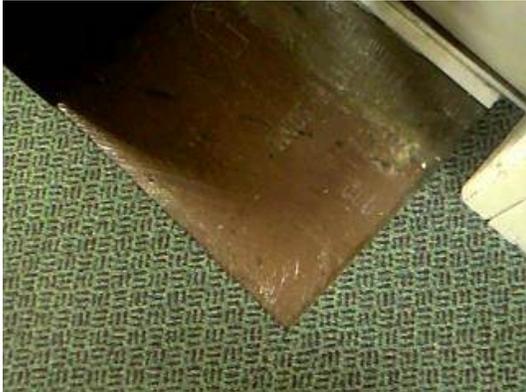
Main activity	Periodic	2

Secondary activity	Periodic	2	
Location	Large Rooms	1	
Extent	<10m <sup>2</sup> and <50m <sup>2</sup> or >10m linear and <50m linear	2	
Accessibility	Occasionally	1	
Occupants	>10	3	
Occupant Hrs	>1 to <3hrs	1	
Occupant frequency	Daily	3	
Maintenance disturbance	Low dist.	1	
Maintenance frequency	<= 1 year	1	
<b>Total Priority Score</b>		<b>6</b>	
Floor / Room	Z-Sub Level 1 012 CORRIDOR		
Description	Brown floor tiles and bitumen adhesive beneath carpet		
Recommendation	Monitor condition and remove if works will disturb		
Sample number	Identified IR014 {AK000205}***		
Sample result	Chrysotile		
<b>Material Assessment Score</b>	<b>3</b>	<b>Risk Level</b>	<b>Low</b>

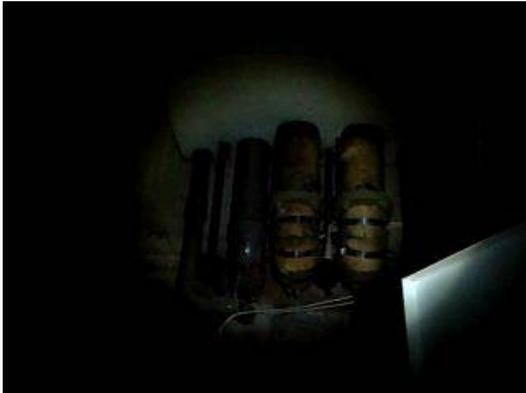
Main activity	Low	1

Secondary activity	Low	1	
Location	Large Rooms	1	
Extent	Small amounts	0	
Accessibility	Easily	2	
Occupants	1 to 3	1	
Occupant Hrs	>1 to <3hrs	1	
Occupant frequency	Daily	3	
Maintenance disturbance	Med. dist.	2	
Maintenance frequency	> 1 per year	2	
<b>Total Priority Score</b>		<b>6</b>	
Floor / Room	Z-Sub Level 1 014 PLANT ROOM		
Description	Gaskets to pipework		
Recommendation	Monitor condition and remove if works will disturb		
Sample number	Identified IR028***		
Sample result	Chrysotile		
<b>Material Assessment Score</b>	<b>3</b>	<b>Risk Level</b>	<b>Low</b>

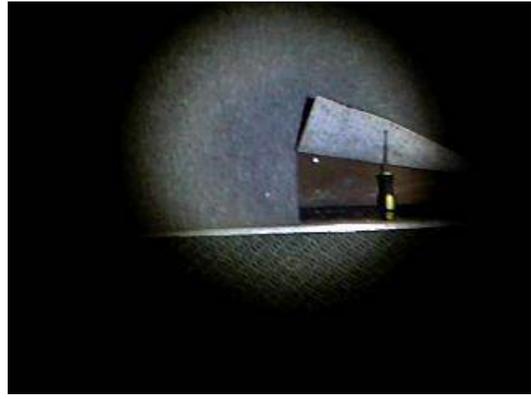
Main activity	Low	1

Secondary activity	Low	1	
Location	Large Rooms	1	
Extent	<10m <sup>2</sup> or < 10m linear	1	
Accessibility	Easily	2	
Occupants	4 to 10	2	
Occupant Hrs	>6 hrs	3	
Occupant frequency	Daily	3	
Maintenance disturbance	Low dist.	1	
Maintenance frequency	<= 1 year	1	
<b>Total Priority Score</b>		<b>6</b>	
Floor / Room	Z-Sub Level 1 015 OFFICE		
Description	Brown floor tiles and bitumen adhesive beneath carpet		
Recommendation	Monitor condition and remove if works will disturb		
Sample number	Identified IR011 {AK000203}***		
Sample result	Chrysotile		
<b>Material Assessment Score</b>	<b>2</b>	<b>Risk Level</b>	<b>Low</b>

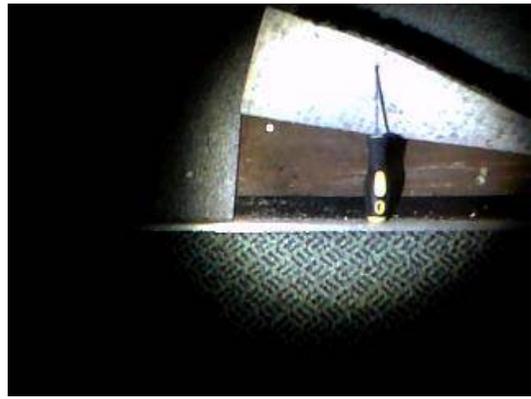
Main activity	Rare	0

Secondary activity	Rare	0	
Location	Rooms <= 100m <sup>2</sup>	2	
Extent	<10m <sup>2</sup> or < 10m linear	1	
Accessibility	Occasionally	1	
Occupants	None	0	
Occupant Hrs	>1 to <3hrs	1	
Occupant frequency	Infrequent	0	
Maintenance disturbance	Low dist.	1	
Maintenance frequency	<= 1 year	1	
<b>Total Priority Score</b>		<b>2</b>	
Floor / Room	Z-Sub Level 1 016 STORE ROOM		
Description	Brown floor tiles and bitumen adhesive beneath carpet		
Recommendation	Monitor condition and remove if works will disturb		
Sample number	Identified IR008 {AK000200}***		
Sample result	Chrysotile		
<b>Material Assessment Score</b>	<b>3</b>	<b>Risk Level</b>	<b>Very Low</b>

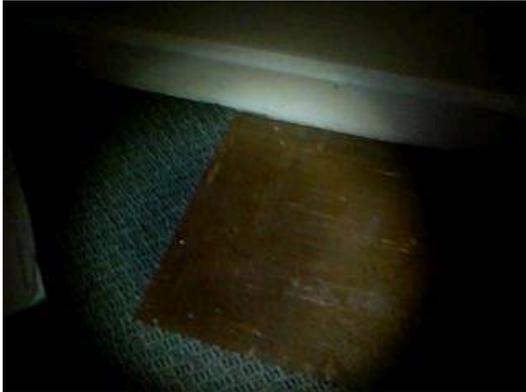
Main activity	Low	1

Secondary activity	Low	1	
Location	Large Rooms	1	
Extent	<10m <sup>2</sup> and <50m <sup>2</sup> or >10m linear and <50m linear	2	
Accessibility	Easily	2	
Occupants	4 to 10	2	
Occupant Hrs	>6 hrs	3	
Occupant frequency	Daily	3	
Maintenance disturbance	Low dist.	1	
Maintenance frequency	<= 1 year	1	
<b>Total Priority Score</b>		<b>7</b>	
Floor / Room	Z-Sub Level 1 017 OFFICE		
Description	Brown floor tiles and bitumen adhesive beneath carpet		
Recommendation	Monitor condition and remove if works will disturb		
Sample number	Identified IR009 {AK000201}***		
Sample result	Chrysotile		
<b>Material Assessment Score</b>	<b>3</b>	<b>Risk Level</b>	<b>Low</b>

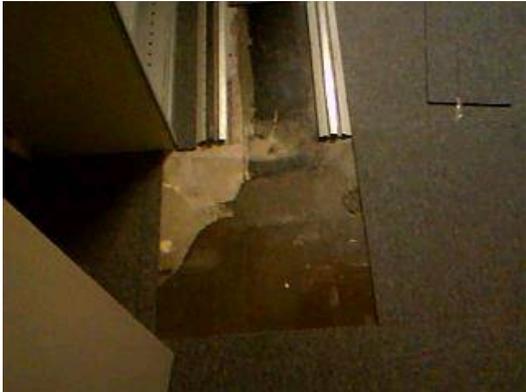
Main activity	Rare	0

Secondary activity	Rare	0	
Location	Rooms <= 100m <sup>2</sup>	2	
Extent	<10m <sup>2</sup> and <50m <sup>2</sup> or >10m linear and <50m linear	2	
Accessibility	Occasionally	1	
Occupants	None	0	
Occupant Hrs	>1 to <3hrs	1	
Occupant frequency	Infrequent	0	
Maintenance disturbance	Low dist.	1	
Maintenance frequency	<= 1 year	1	
<b>Total Priority Score</b>		<b>3</b>	
Floor / Room	Z-Sub Level 1 018 STORE ROOM		
Description	Brown floor tiles and bitumen adhesive beneath carpet		
Recommendation	Monitor condition and remove if works will disturb		
Sample number	Identified IR010 {AK000202}***		
Sample result	Chrysotile		
<b>Material Assessment Score</b>	<b>3</b>	<b>Risk Level</b>	<b>Very Low</b>

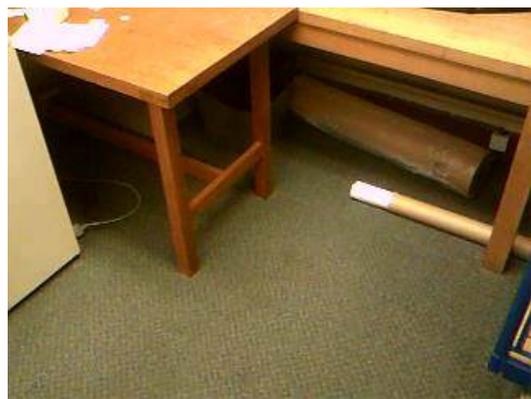
Main activity	Low	1

Secondary activity	Low	1	
Location	Large Rooms	1	
Extent	<10m <sup>2</sup> or < 10m linear	1	
Accessibility	Easily	2	
Occupants	4 to 10	2	
Occupant Hrs	>6 hrs	3	
Occupant frequency	Daily	3	
Maintenance disturbance	Low dist.	1	
Maintenance frequency	<= 1 year	1	
<b>Total Priority Score</b>		<b>6</b>	
Floor / Room	Z-Sub Level 1 019 POST ROOM		
Description	Brown floor tiles and bitumen adhesive beneath carpet		
Recommendation	Monitor condition and remove if works will disturb		
Sample number	Identified IR012 {AK000204}***		
Sample result	Chrysotile		
<b>Material Assessment Score</b>	<b>3</b>	<b>Risk Level</b>	<b>Low</b>

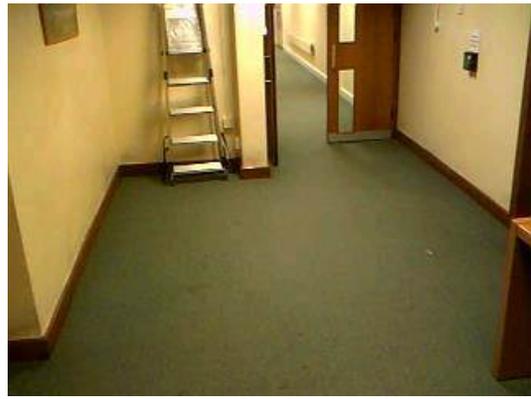
Main activity	Periodic	2

Secondary activity	Periodic	2	
Location	Large Rooms	1	
Extent	<10m <sup>2</sup> and <50m <sup>2</sup> or >10m linear and <50m linear	2	
Accessibility	Occasionally	1	
Occupants	>10	3	
Occupant Hrs	>1 to <3hrs	1	
Occupant frequency	Daily	3	
Maintenance disturbance	Low dist.	1	
Maintenance frequency	<= 1 year	1	
<b>Total Priority Score</b>		<b>6</b>	
Floor / Room	Z-Sub Level 1 029 CORRIDOR		
Description	Brown floor tiles and bitumen adhesive beneath carpet		
Recommendation	Monitor condition and remove if works will disturb		
Sample number	Identified IR003 {AK000182}***		
Sample result	Chrysotile		
<b>Material Assessment Score</b>	<b>3</b>	<b>Risk Level</b>	<b>Low</b>

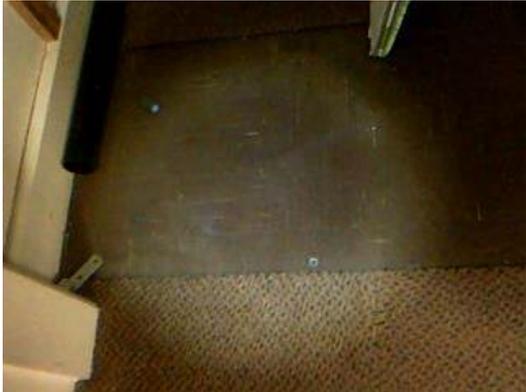
Main activity	Periodic	2

Secondary activity	Periodic	2	
Location	Rooms <= 100m2	2	
Extent	<10m <sup>2</sup> and <50m <sup>2</sup> or >10m linear and <50m linear	2	
Accessibility	Easily	2	
Occupants	4 to 10	2	
Occupant Hrs	>3 to <6hrs	2	
Occupant frequency	Weekly	2	
Maintenance disturbance	Med. dist.	2	
Maintenance frequency	> 1 per year	2	
<b>Total Priority Score</b>		<b>8</b>	
Floor / Room	Z-Sub Level 1 031 OTHER		
Description	Brown floor tiles and bitumen adhesive beneath carpet		
Recommendation	Monitor condition and remove if works will disturb		
Sample number	Identified IR007 {AK000186}***		
Sample result	Chrysotile		
<b>Material Assessment Score</b>	<b>3</b>	<b>Risk Level</b>	<b>Low</b>

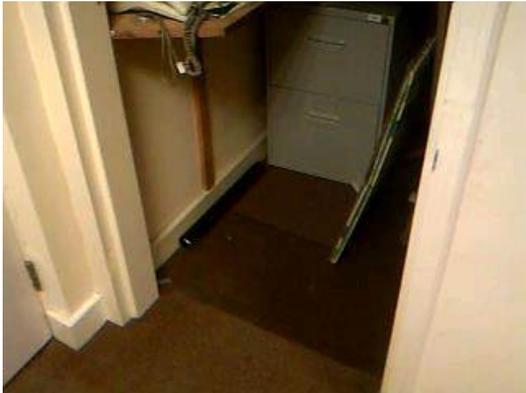
Main activity	Rare	0

Secondary activity	Rare	0	
Location	Rooms <= 100m2	2	
Extent	<10m <sup>2</sup> or < 10m linear	1	
Accessibility	Occasionally	1	
Occupants	None	0	
Occupant Hrs	>1 to <3hrs	1	
Occupant frequency	Infrequent	0	
Maintenance disturbance	Low dist.	1	
Maintenance frequency	<= 1 year	1	
<b>Total Priority Score</b>		<b>2</b>	
Floor / Room	Z-Sub Level 1 033 STORE ROOM		
Description	Brown floor tiles and bitumen adhesive below		
Recommendation	Monitor condition and remove if works will disturb		
Sample number	Identified IR006 {AK000185}***		
Sample result	Chrysotile		
<b>Material Assessment Score</b>	<b>3</b>	<b>Risk Level</b>	<b>Very Low</b>

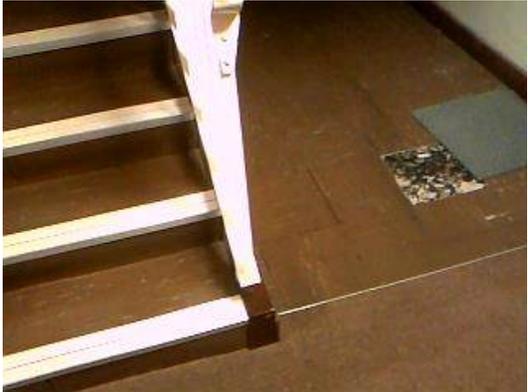
Main activity	Periodic	2

Secondary activity	Periodic	2	
Location	Large Rooms	1	
Extent	<10m <sup>2</sup> and <50m <sup>2</sup> or >10m linear and <50m linear	2	
Accessibility	Occasionally	1	
Occupants	>10	3	
Occupant Hrs	>1 to <3hrs	1	
Occupant frequency	Daily	3	
Maintenance disturbance	Low dist.	1	
Maintenance frequency	<= 1 year	1	
<b>Total Priority Score</b>		<b>6</b>	
Floor / Room	Z-Sub Level 1 034 STAIRWELL		
Description	Brown floor tiles and bitumen adhesive below - to floor and stair risers/ treads		
Recommendation	Monitor condition and remove if works will disturb		
Sample number	Identified IR001 {AK000180}***		
Sample result	Chrysotile		
<b>Material Assessment Score</b>	<b>3</b>	<b>Risk Level</b>	<b>Low</b>

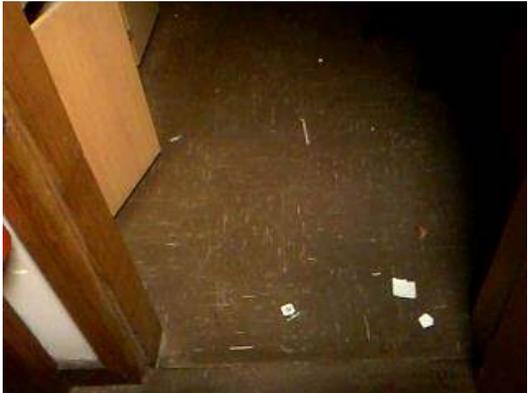
Main activity	Rare	0

Secondary activity	Rare	0	
Location	Rooms <= 100m <sup>2</sup>	2	
Extent	<10m <sup>2</sup> or < 10m linear	1	
Accessibility	Occasionally	1	
Occupants	None	0	
Occupant Hrs	>1 to <3hrs	1	
Occupant frequency	Infrequent	0	
Maintenance disturbance	Low dist.	1	
Maintenance frequency	<= 1 year	1	
<b>Total Priority Score</b>		<b>2</b>	
Floor / Room	Z-Sub Level 1 035 STORE ROOM		
Description	Brown floor tiles and bitumen adhesive below		
Recommendation	Monitor condition and remove if works will disturb		
Sample number	Identified IR002 {AK000181}***		
Sample result	Chrysotile		
<b>Material Assessment Score</b>	<b>3</b>	<b>Risk Level</b>	<b>Very Low</b>

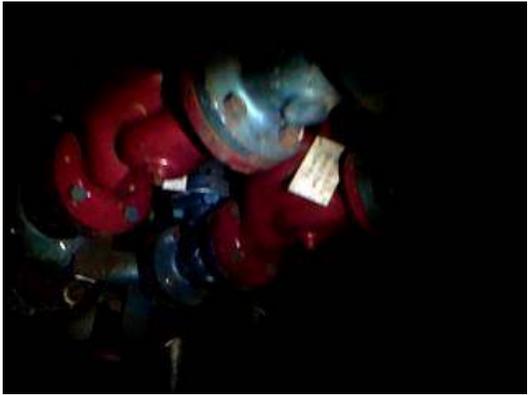
Main activity	Low	1

Secondary activity	Low	1	
Location	Large Rooms	1	
Extent	Small amounts	0	
Accessibility	Easily	2	
Occupants	1 to 3	1	
Occupant Hrs	>1 to <3hrs	1	
Occupant frequency	Daily	3	
Maintenance disturbance	Med. dist.	2	
Maintenance frequency	> 1 per year	2	
<b>Total Priority Score</b>		<b>6</b>	
Floor / Room	Z-Sub Level 1 051 PLANT ROOM		
Description	IR029 - Gaskets to pipework		
Recommendation	Conduct further investigation prior to relevant maintenance / refurbishment works		
Sample number			
Sample result	Presumed Crocidolite (or unknown)		
<b>Material Assessment Score</b>	<b>5</b>	<b>Risk Level</b>	<b>Low</b>

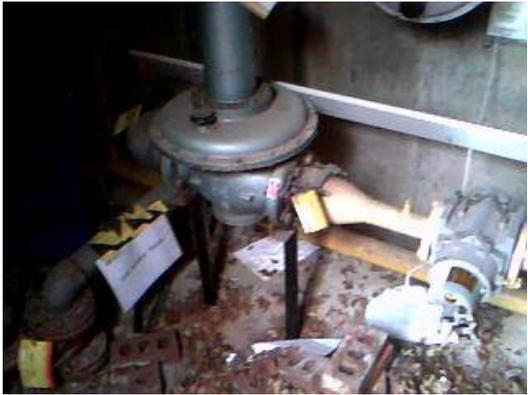
Main activity	Rare	0

Secondary activity	Rare	0	
Location	Rooms <= 100m2	2	
Extent	Small amounts	0	
Accessibility	Occasionally	1	
Occupants	None	0	
Occupant Hrs	>1 to <3hrs	1	
Occupant frequency	Infrequent	0	
Maintenance disturbance	Low dist.	1	
Maintenance frequency	<= 1 year	1	
<b>Total Priority Score</b>		<b>2</b>	
Floor / Room	Z-Sub Level 1 052 CUPBOARD - METER		
Description	Gaskets to pipework		
Recommendation	Monitor condition and remove if works will disturb		
Sample number	Identified IR015 {AK000206}***		
Sample result	Chrysotile		
<b>Material Assessment Score</b>	<b>4</b>	<b>Risk Level</b>	<b>Very Low</b>

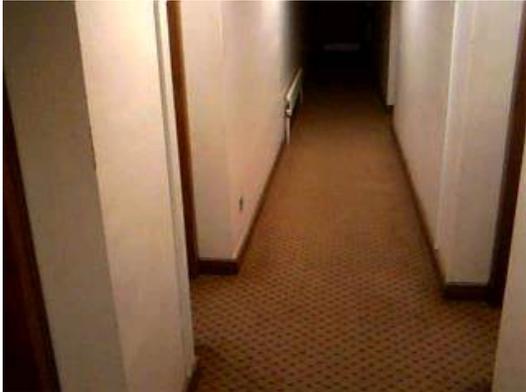
Main activity	Periodic	2

Secondary activity	Periodic	2	
Location	Large Rooms	1	
Extent	<10m <sup>2</sup> and <50m or >10m linear and <50m linear	2	
Accessibility	Occasionally	1	
Occupants	>10	3	
Occupant Hrs	>1 to <3hrs	1	
Occupant frequency	Daily	3	
Maintenance disturbance	Low dist.	1	
Maintenance frequency	<= 1 year	1	
<b>Total Priority Score</b>		<b>6</b>	
Floor / Room	Ground Floor 004 CORRIDOR		
Description	Brown floor tiles and bitumen adhesive beneath carpet		
Recommendation	Monitor condition and remove if works will disturb		
Sample number	Identified IR030 {AK000193}***		
Sample result	Chrysotile		
<b>Material Assessment Score</b>	<b>3</b>	<b>Risk Level</b>	<b>Low</b>

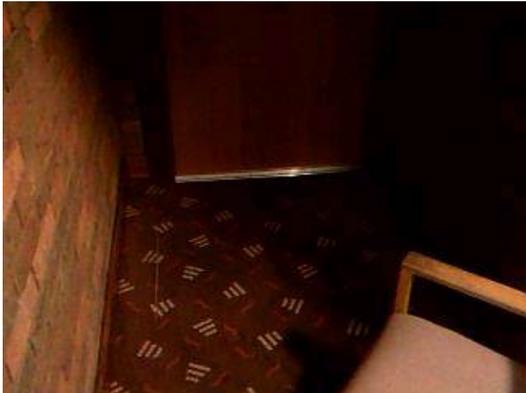
Main activity	Low	1

Secondary activity	Low	1	
Location	Large Rooms	1	
Extent	<10m <sup>2</sup> or < 10m linear	1	
Accessibility	Occasionally	1	
Occupants	>10	3	
Occupant Hrs	>1 to <3hrs	1	
Occupant frequency	Daily	3	
Maintenance disturbance	Low dist.	1	
Maintenance frequency	<= 1 year	1	
<b>Total Priority Score</b>		<b>5</b>	
Floor / Room	Ground Floor 024 LOBBY		
Description	Brown floor tiles and bitumen adhesive below		
Recommendation	Monitor condition and remove if works will disturb		
Sample number	Identified IR021 {AK000194}***		
Sample result	Chrysotile		
<b>Material Assessment Score</b>	<b>3</b>	<b>Risk Level</b>	<b>Low</b>

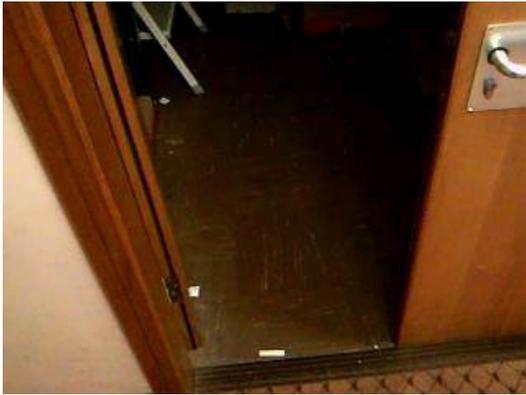
Main activity	Rare	0

Secondary activity	Rare	0	
Location	Rooms <= 100m2	2	
Extent	<10m <sup>2</sup> or < 10m linear	1	
Accessibility	Occasionally	1	
Occupants	None	0	
Occupant Hrs	>1 to <3hrs	1	
Occupant frequency	Infrequent	0	
Maintenance disturbance	Low dist.	1	
Maintenance frequency	<= 1 year	1	
<b>Total Priority Score</b>		<b>2</b>	
Floor / Room	Ground Floor 032 STORE ROOM		
Description	Brown floor tiles and bitumen adhesive below		
Recommendation	Monitor condition and remove if works will disturb		
Sample number	Identified IR019 {AK000191}***		
Sample result	Chrysotile		
<b>Material Assessment Score</b>	<b>2</b>	<b>Risk Level</b>	<b>Very Low</b>

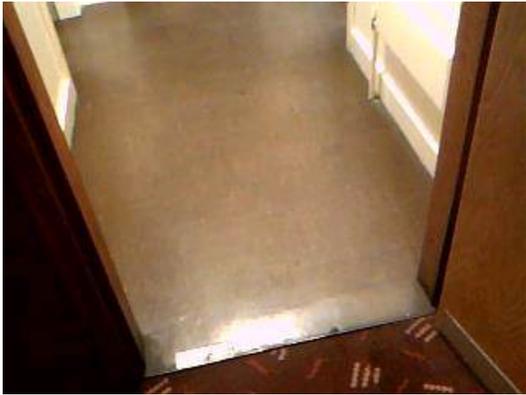
Main activity	Low	1

Secondary activity	Low	1	
Location	Large Rooms	1	
Extent	<10m <sup>2</sup> or < 10m linear	1	
Accessibility	Occasionally	1	
Occupants	>10	3	
Occupant Hrs	>1 to <3hrs	1	
Occupant frequency	Daily	3	
Maintenance disturbance	Low dist.	1	
Maintenance frequency	<= 1 year	1	
<b>Total Priority Score</b>		<b>5</b>	
Floor / Room	Ground Floor 038 LOBBY		
Description	Brown floor tiles and bitumen adhesive below		
Recommendation	Monitor condition and remove if works will disturb		
Sample number	Identified IR024 {AK000196}***		
Sample result	Chrysotile		
<b>Material Assessment Score</b>	<b>3</b>	<b>Risk Level</b>	<b>Low</b>

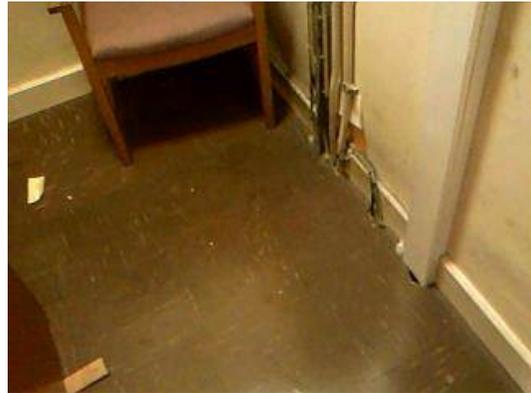
Main activity	Rare	0

Secondary activity	Rare	0	
Location	Rooms <= 100m2	2	
Extent	<10m <sup>2</sup> or < 10m linear	1	
Accessibility	Occasionally	1	
Occupants	None	0	
Occupant Hrs	>1 to <3hrs	1	
Occupant frequency	Infrequent	0	
Maintenance disturbance	Low dist.	1	
Maintenance frequency	<= 1 year	1	
<b>Total Priority Score</b>		<b>2</b>	
Floor / Room	Ground Floor 042 CUPBOARD - STORE		
Description	Brown floor tiles and bitumen adhesive beneath carpet		
Recommendation	Monitor condition and remove if works will disturb		
Sample number	Identified IR022 {AK000198}***		
Sample result	Chrysotile		
<b>Material Assessment Score</b>	<b>3</b>	<b>Risk Level</b>	<b>Very Low</b>

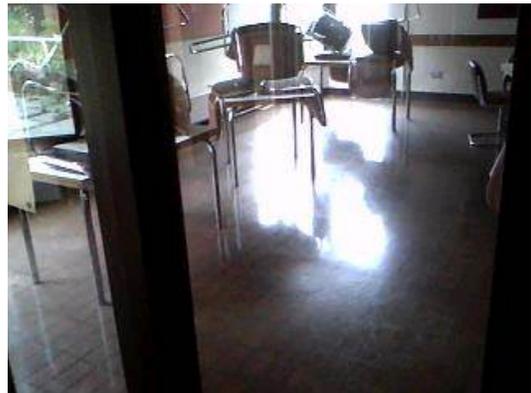
Main activity	Low	1

Secondary activity	Low	1	
Location	Large Rooms	1	
Extent	<10m <sup>2</sup> and <50m <sup>2</sup> or >10m linear and <50m linear	2	
Accessibility	Occasionally	1	
Occupants	>10	3	
Occupant Hrs	>1 to <3hrs	1	
Occupant frequency	Daily	3	
Maintenance disturbance	Low dist.	1	
Maintenance frequency	<= 1 year	1	
<b>Total Priority Score</b>		<b>5</b>	
Floor / Room	Ground Floor 047 CAFE		
Description	Brown floor tiles and bitumen adhesive below		
Recommendation	Monitor condition and remove if works will disturb		
Sample number	Identified IR025 {AK000197}***		
Sample result	Chrysotile		
<b>Material Assessment Score</b>	<b>3</b>	<b>Risk Level</b>	<b>Low</b>

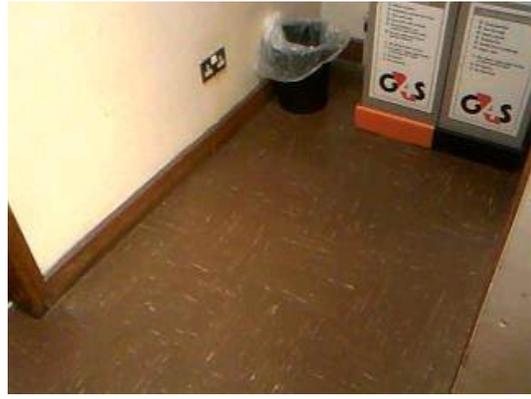
Main activity	Low	1

Secondary activity	Low	1	
Location	Large Rooms	1	
Extent	<10m <sup>2</sup> or < 10m linear	1	
Accessibility	Occasionally	1	
Occupants	>10	3	
Occupant Hrs	>1 to <3hrs	1	
Occupant frequency	Daily	3	
Maintenance disturbance	Low dist.	1	
Maintenance frequency	<= 1 year	1	
<b>Total Priority Score</b>		<b>5</b>	
Floor / Room	Ground Floor 056 LOBBY		
Description	Brown floor tiles and bitumen adhesive below		
Recommendation	Monitor condition and remove if works will disturb		
Sample number	Identified IR016 {AK000188}***		
Sample result	Chrysotile		
<b>Material Assessment Score</b>	<b>3</b>	<b>Risk Level</b>	<b>Low</b>

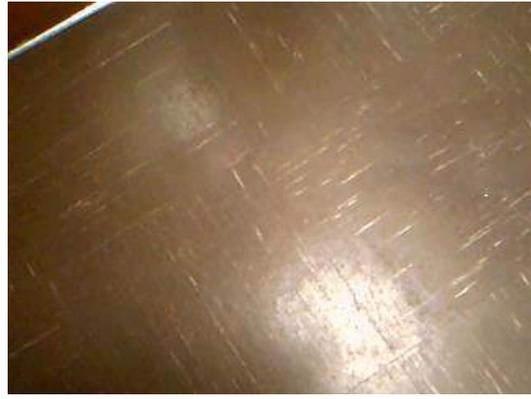
Main activity	Low	1

Secondary activity	Low	1	
Location	Large Rooms	1	
Extent	<10m <sup>2</sup> or < 10m linear	1	
Accessibility	Easily	2	
Occupants	4 to 10	2	
Occupant Hrs	>6 hrs	3	
Occupant frequency	Daily	3	
Maintenance disturbance	Low dist.	1	
Maintenance frequency	<= 1 year	1	
<b>Total Priority Score</b>		<b>6</b>	
Floor / Room	Ground Floor 058 OFFICE		
Description	Brown floor tiles and bitumen adhesive beneath carpet		
Recommendation	Monitor condition and remove if works will disturb		
Sample number	Identified IR017 {AK000189}***		
Sample result	Chrysotile		
<b>Material Assessment Score</b>	<b>3</b>	<b>Risk Level</b>	<b>Low</b>

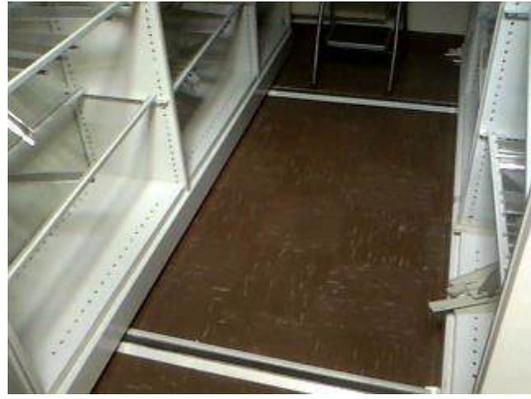
Main activity	Rare	0

Secondary activity	Rare	0	
Location	Rooms <= 100m2	2	
Extent	<10m <sup>2</sup> or < 10m linear	1	
Accessibility	Occasionally	1	
Occupants	None	0	
Occupant Hrs	>1 to <3hrs	1	
Occupant frequency	Infrequent	0	
Maintenance disturbance	Low dist.	1	
Maintenance frequency	<= 1 year	1	
<b>Total Priority Score</b>		<b>2</b>	
Floor / Room	Ground Floor 059 STORE ROOM		
Description	Brown floor tiles and bitumen adhesive below		
Recommendation	Monitor condition and remove if works will disturb		
Sample number	Identified IR018 {AK000190}***		
Sample result	Chrysotile		
<b>Material Assessment Score</b>	<b>3</b>	<b>Risk Level</b>	<b>Very Low</b>

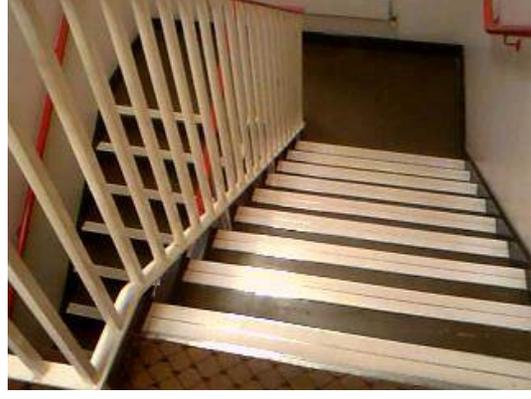
Main activity	Periodic	2

Secondary activity	Periodic	2	
Location	Large Rooms	1	
Extent	<10m <sup>2</sup> and <50m <sup>2</sup> or >10m linear and <50m linear	2	
Accessibility	Occasionally	1	
Occupants	>10	3	
Occupant Hrs	>1 to <3hrs	1	
Occupant frequency	Daily	3	
Maintenance disturbance	Low dist.	1	
Maintenance frequency	<= 1 year	1	
<b>Total Priority Score</b>		<b>6</b>	
Floor / Room	Ground Floor 071 STAIRWELL		
Description	Brown floor tiles and bitumen adhesive below - to floor (under carpet) and stair risers/treads (exposed)		
Recommendation	Monitor condition and remove if works will disturb		
Sample number	Identified IR020 {AK000192}***		
Sample result	Chrysotile		
<b>Material Assessment Score</b>	<b>3</b>	<b>Risk Level</b>	<b>Low</b>

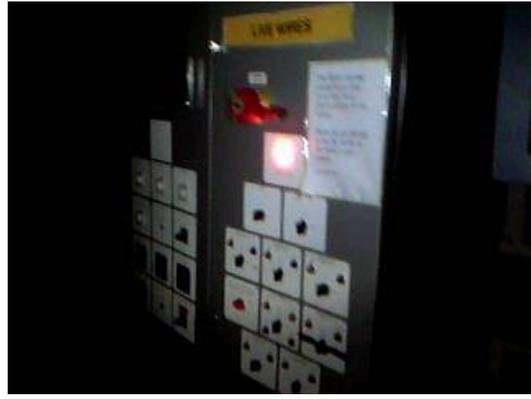
Main activity	Low	1

Secondary activity	Low	1	
Location	Large Rooms	1	
Extent	<10m <sup>2</sup> or < 10m linear	1	
Accessibility	Easily	2	
Occupants	1 to 3	1	
Occupant Hrs	>1 to <3hrs	1	
Occupant frequency	Daily	3	
Maintenance disturbance	Med. dist.	2	
Maintenance frequency	> 1 per year	2	
<b>Total Priority Score</b>		<b>6</b>	
Floor / Room	Roof Void 001 PLANT ROOM		
Description	IR026 - Presumed flashguards within live electrics		
Recommendation	Conduct further investigation prior to relevant maintenance / refurbishment works		
Sample number			
Sample result	Presumed Crocidolite (or unknown)		
<b>Material Assessment Score</b>	<b>6</b>	<b>Risk Level</b>	<b>Low</b>

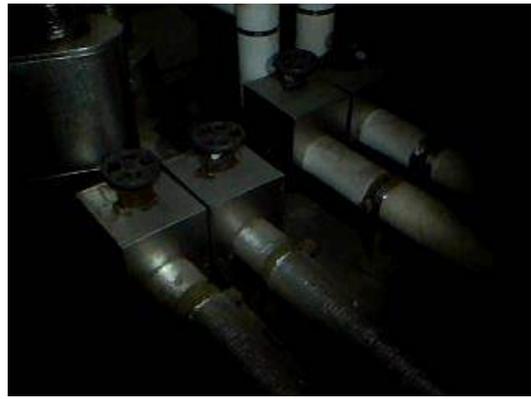
Main activity	Low	1

Secondary activity	Low	1	
Location	Large Rooms	1	
Extent	Small amounts	0	
Accessibility	Easily	2	
Occupants	1 to 3	1	
Occupant Hrs	>1 to <3hrs	1	
Occupant frequency	Daily	3	
Maintenance disturbance	Med. dist.	2	
Maintenance frequency	> 1 per year	2	
<b>Total Priority Score</b>		<b>6</b>	
Floor / Room	Roof Void 001 PLANT ROOM		
Description	IR027 - Presumed gaskets to pipework		
Recommendation	Conduct further investigation prior to relevant maintenance / refurbishment works		
Sample number			
Sample result	Presumed Crocidolite (or unknown)		
<b>Material Assessment Score</b>	<b>5</b>	<b>Risk Level</b>	<b>Low</b>
