Asbestos Reinspection Report

Richmond Magistrates Court, The Court House, Parkshot, Richmond, TW9 2RF

Title: Richmond Magistrates Court - Reinspection Survey

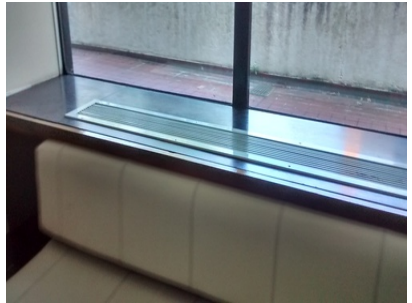
Building	Level	Location	Item / Product Examined	Sample No.	Material Description	Fibre Type	Material Score	Extent	Risk Level Assessment	Initial Control Recommendation	Photograph
Richmond Magistrates Court	0	097/foyer	window cill S-207783		Asbestos-containing composite	Strongly Presume Chrysotile	3	9 Lm.	R3	Reinspect Periodically

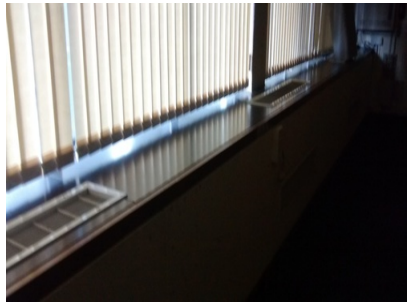
Richmond Magistrates Court	0	100/general office	window cill S-207783		Asbestos-containing composite	Strongly Presume Chrysotile	3	9 Lm.	R3	Reinspect Periodically

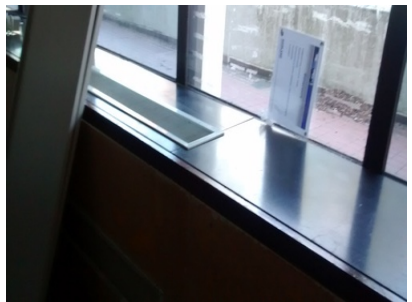
Richmond Magistrates Court	0	103/computer room	window cill S-207783		Asbestos-containing composite	Strongly Presume Chrysotile	3	5 Lm.	R3	Reinspect Periodically

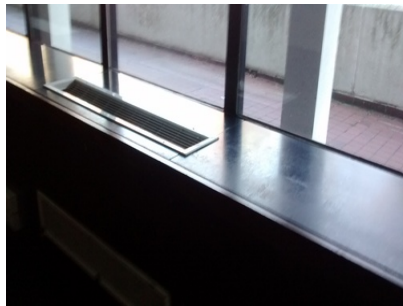
Building	Level	Location	Item / Product Examined	Sample No.	Material Description	Fibre Type	Material Score	Extent	Risk Level Assessment	Initial Control Recommendation	Photograph
Richmond Magistrates Court	0	104/warrant office	window cill S-207783		Asbestos-containing composite	Strongly Presume Chrysotile	3	3 Lm.	R3	Reinspect Periodically

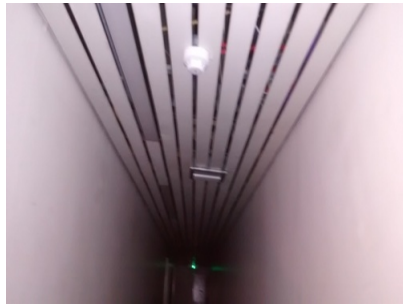
Richmond Magistrates Court	0	105 corridor	mastic to ducting S-207783		Asbestos-containing composite	Strongly Presume Chrysotile	3	Throughout Location	R3	Reinspect Periodically

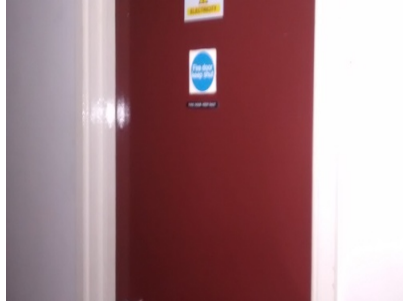
Richmond Magistrates Court	0	106/electrical intake	floor tiles S-207783		Asbestos-containing composite	Strongly Presume Chrysotile	3	3 Sqm.	R3	Reinspect Periodically

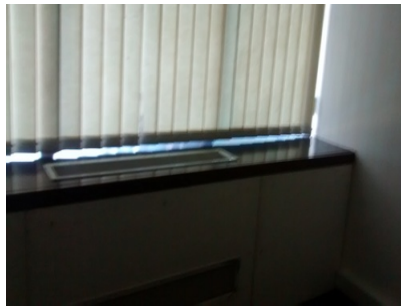
Building	Level	Location	Item / Product Examined	Sample No.	Material Description	Fibre Type	Material Score	Extent	Risk Level Assessment	Initial Control Recommendation	Photograph
Richmond Magistrates Court	0	108/office	window cill S-207783		Asbestos-containing composite	Strongly Presume Chrysotile	3	3 Lm.	R3	Reinspect Periodically

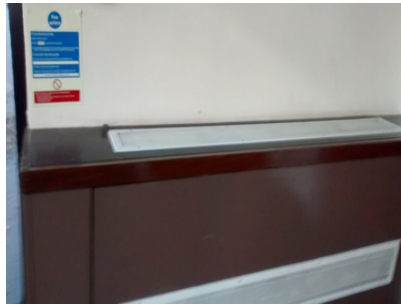
Richmond Magistrates Court	0	109/stairwell	window cill S-207783		Asbestos-containing composite	Strongly Presume Chrysotile	3	2 Lm.	R3	Reinspect Periodically

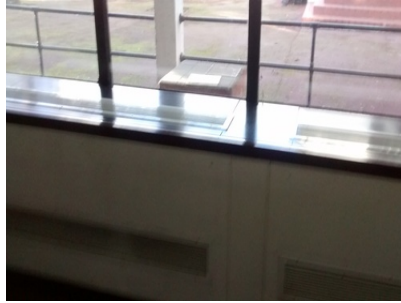
Richmond Magistrates Court	0	110/office	window cill S-207783		Asbestos-containing composite	Strongly Presume Chrysotile	3	4 Lm.	R3	Reinspect Periodically

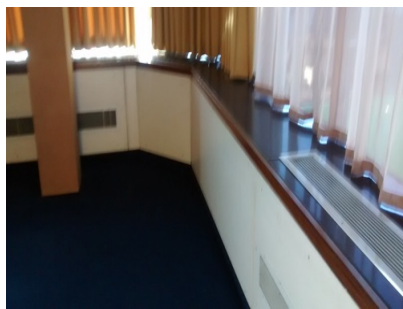
Building	Level	Location	Item / Product Examined	Sample No.	Material Description	Fibre Type	Material Score	Extent	Risk Level Assessment	Initial Control Recommendation	Photograph
Richmond Magistrates Court	0	111/office	window cill S-207783		Asbestos-containing composite	Strongly Presume Chrysotile	3	3 Lm.	R3	Reinspect Periodically

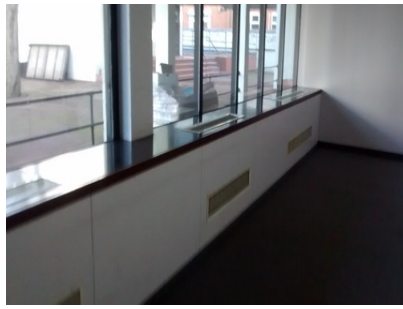
Richmond Magistrates Court	0	113/staff room	window cill S-207783		Asbestos-containing composite	Strongly Presume Chrysotile	3	7 Lm.	R3	Reinspect Periodically

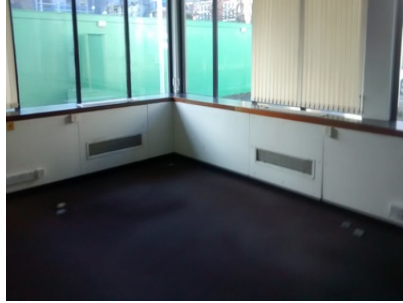
Richmond Magistrates Court	0	116/office	window cill S-207783		Asbestos-containing composite	Strongly Presume Chrysotile	3	14 Lm.	R3	Reinspect Periodically

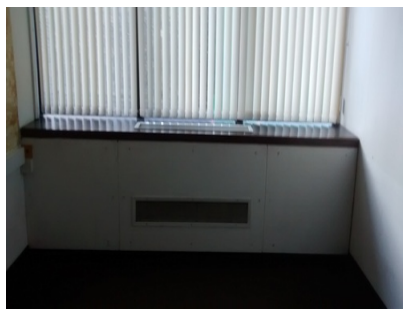
Building	Level	Location	Item / Product Examined	Sample No.	Material Description	Fibre Type	Material Score	Extent	Risk Level Assessment	Initial Control Recommendation	Photograph
Richmond Magistrates Court	0	117/office	window cill S-207783		Asbestos-containing composite	Strongly Presume Chrysotile	3	3 Lm.	R3	Reinspect Periodically

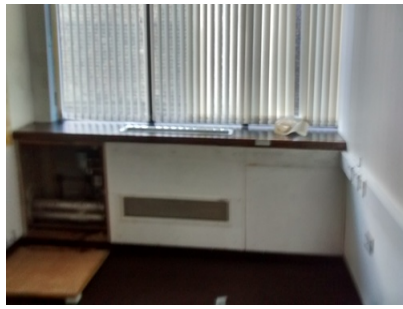
Richmond Magistrates Court	0	118/office	window cill S-207783		Asbestos-containing composite	Strongly Presume Chrysotile	3	4 Lm.	R3	Reinspect Periodically

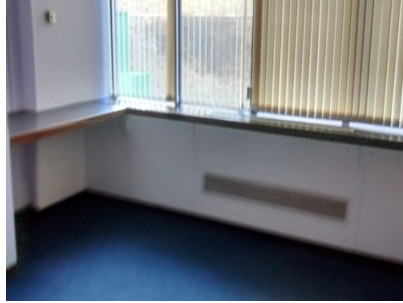
Richmond Magistrates Court	0	119/office and wc	window cill S-207783		Asbestos-containing composite	Strongly Presume Chrysotile	3	6 Lm.	R3	Reinspect Periodically

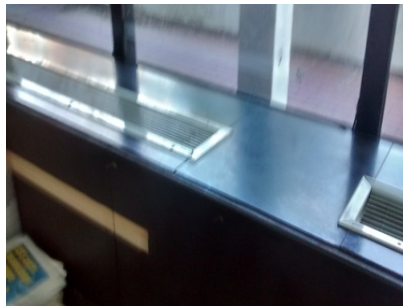
Building	Level	Location	Item / Product Examined	Sample No.	Material Description	Fibre Type	Material Score	Extent	Risk Level Assessment	Initial Control Recommendation	Photograph
Richmond Magistrates Court	0	127/witness service	window cill S-207783		Asbestos-containing composite	Strongly Presume Chrysotile	3	3 Lm.	R3	Reinspect Periodically

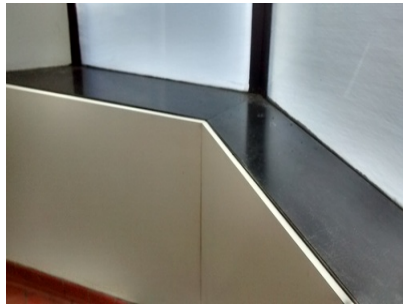
Richmond Magistrates Court	1	006/male wc	window cill ref S-207783		Asbestos-containing composite	Strongly Presume Chrysotile	3	3 Lm.	R3	Reinspect Periodically

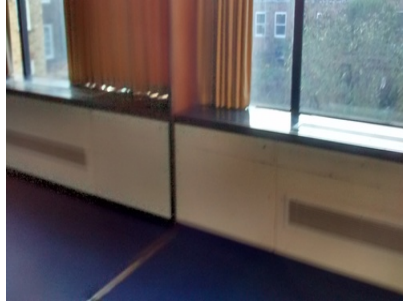
Richmond Magistrates Court	1	007/009/ magistrates retiring room	window cill ref S-207783		Asbestos-containing composite	Strongly Presume Chrysotile	3	3 Lm.	R3	Reinspect Periodically

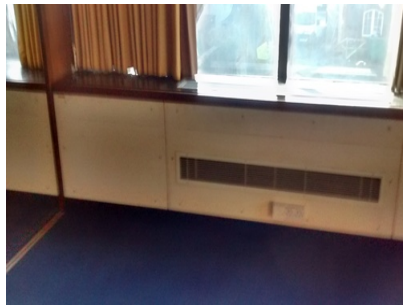
Building	Level	Location	Item / Product Examined	Sample No.	Material Description	Fibre Type	Material Score	Extent	Risk Level Assessment	Initial Control Recommendation	Photograph
Richmond Magistrates Court	1	010/magistrates retiring room	window sill ref S-207783		Asbestos-containing composite	Strongly Presume Chrysotile	3	3 Lm.	R3	Reinspect Periodically

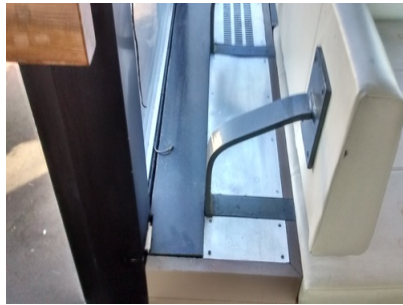
Richmond Magistrates Court	1	011/magistrates retiring room 4	window sill ref S-207783		Asbestos-containing composite	Strongly Presume Chrysotile	3	6 Lm.	R3	Reinspect Periodically	
Richmond Magistrates Court	1	025/corridor	window sill ref S-207783		Asbestos-containing composite	Strongly Presume Chrysotile	3	6 Lm.	R3	Reinspect Periodically

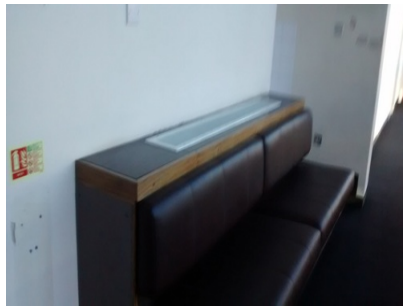
Richmond Magistrates Court	1	053/corridor	window sill		Asbestos-containing composite	Strongly Presume Chrysotile	3	2.5 Lm.	R3	Reinspect Periodically

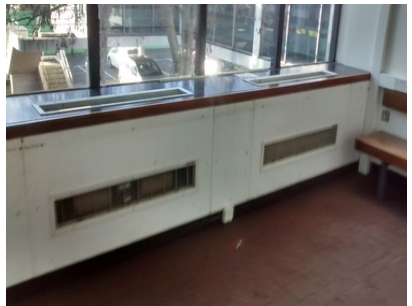
Building	Level	Location	Item / Product Examined	Sample No.	Material Description	Fibre Type	Material Score	Extent	Risk Level Assessment	Initial Control Recommendation	Photograph
Richmond Magistrates Court	1	057/office and ushers	window sill ref S-207783		Asbestos-containing composite	Strongly Presume Chrysotile	3	4 Lm.	R3	Reinspect Periodically

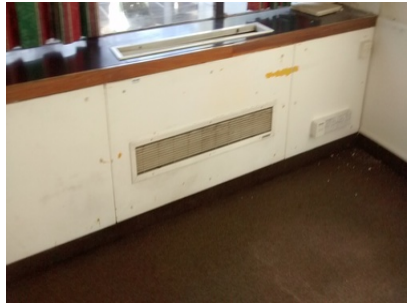
Richmond Magistrates Court	1	058/ushers	window sill ref S-207783		Asbestos-containing composite	Strongly Presume Chrysotile	3	4 Lm.	R3	Reinspect Periodically

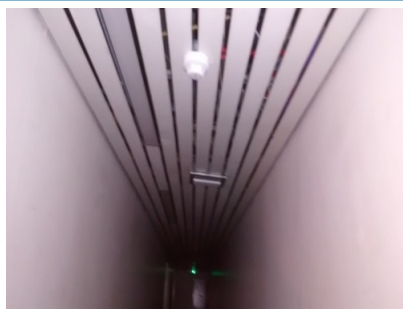
Building	Level	Location	Item / Product Examined	Accessibility	Access Comments	Photograph
Richmond Magistrates Court	0	105 corridor	mastic to ducting S-207783	No Access	damage to decorative surfaces

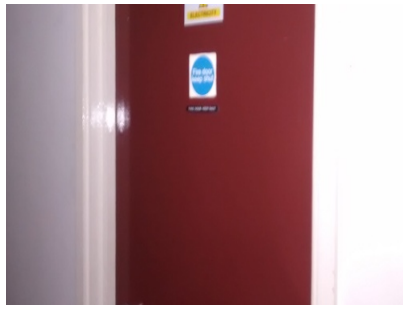
Richmond Magistrates Court	0	106/electrical intake	floor tiles S-207783	No Access	locked
