**Due Diligence Asbestos Inspection
Of**

**Camberwell Magistrates Court
15 D'Eynsford Road
Camberwell Green
London SE5 7UP**

HLAP45322/004R

October 2016

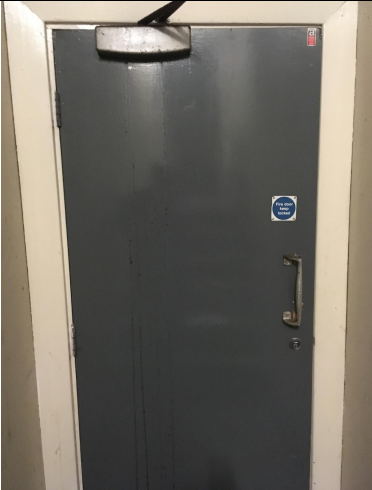
Photo 1: Insulating Board fillet into Fire door (Basement . Engineer Stairs)	Photo 2: Rope (Basement . Engineer Stairs)

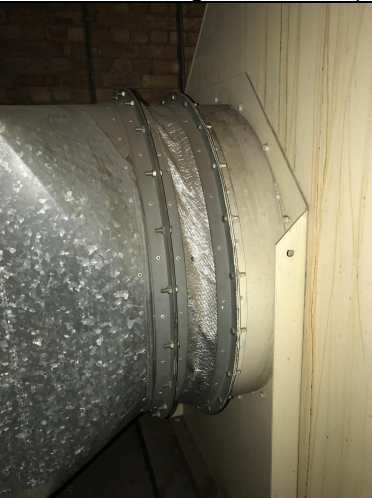
Photo 3: Gathering to Air Handling Unit (Basement . Plan room 3)	Photo 4: Gaskets on gas pipe line and loose gaskets (Basement - Plant Room 1)

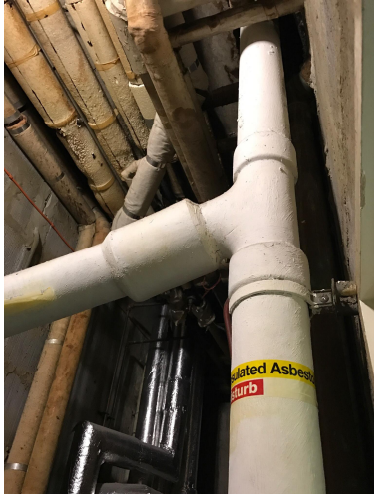
2. Cement flue pipework runs throughout the building within riser voids from the lower ground floor to the roof
3. Old mastic sealing joints to a large quantity of AHU ductwork exist throughout the building; these should be presumed until sampling can be carried out by a qualified person.

Photo 5: Example of Cement pipe

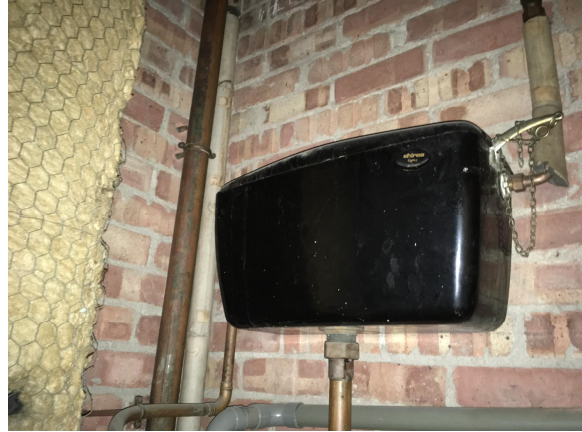
Photo 6: Example of toilet cistern

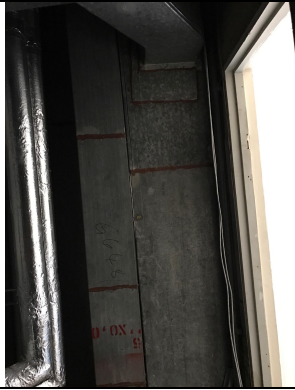
Photo 7: Example of red/brown mastic to air handling unit

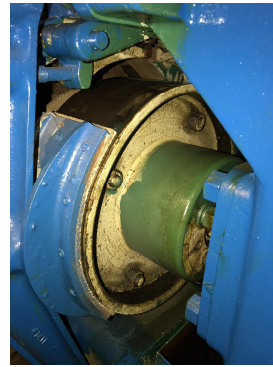
Photo 8: Brake pads to lift motor (Third Floor, Lift 6 Motor room)

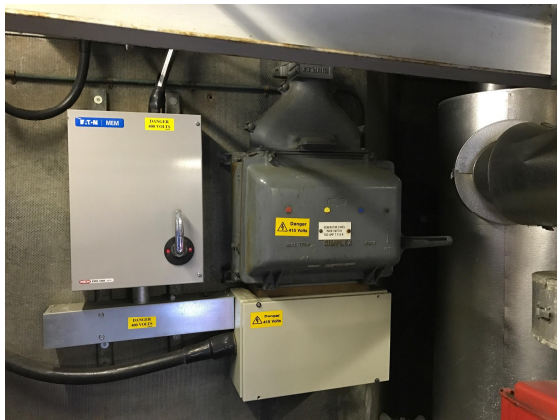
Photo 9: Example of Woven textile flashguards within electrical box

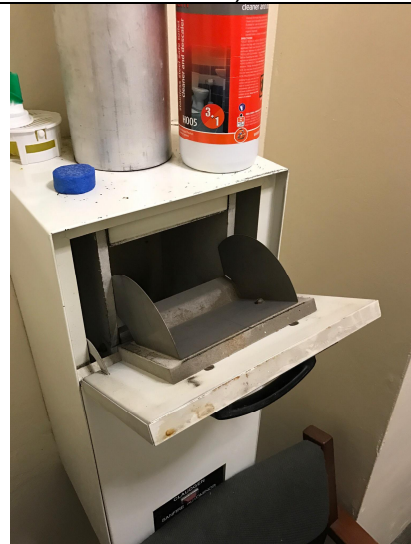
Photo 10: Example of Asbestos Insulating Board panel within incinerette

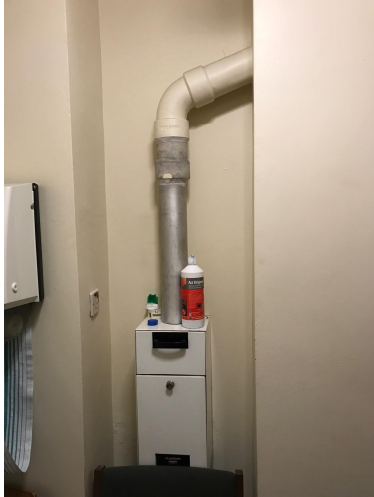
Photo 11: Example of cement flue pipe to incinerator

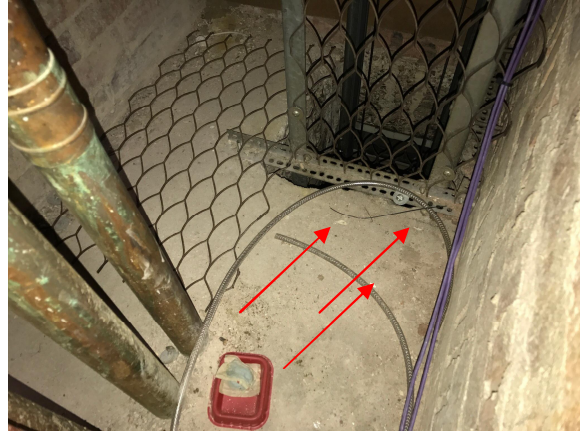
Photo 12: Insulating Board debris to floor from doc lift

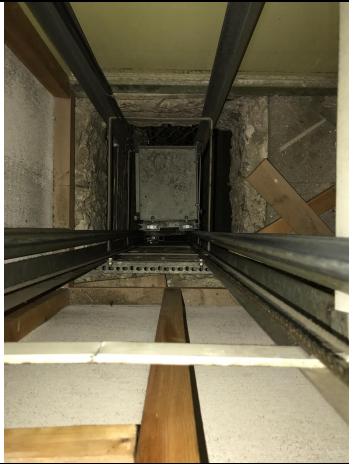
Photo 13: Insulating Board to doc lift

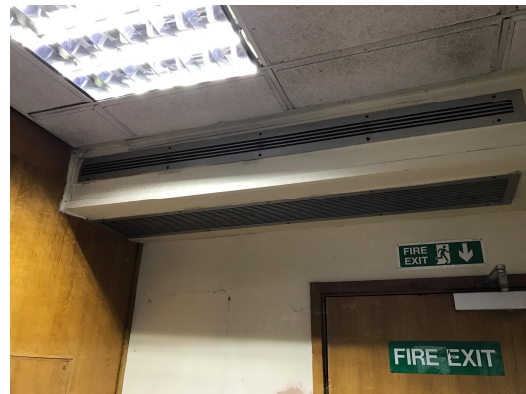
Photo 14: Insulating Board surround to Air Condition Unit

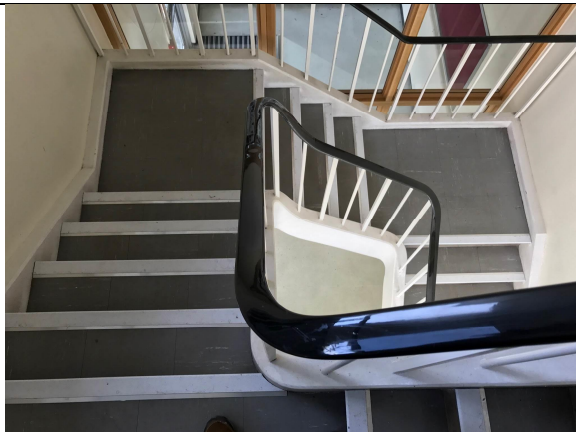
Photo 15: Stair Nosing and Vinyl floor tiles (First Floor, Staff stairs)

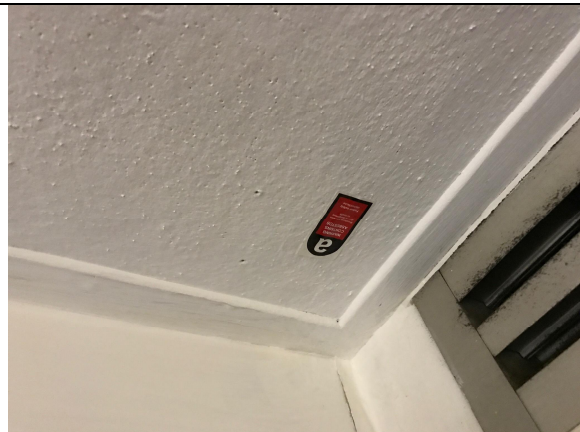
Photo 16: Example of paper coating to ceiling

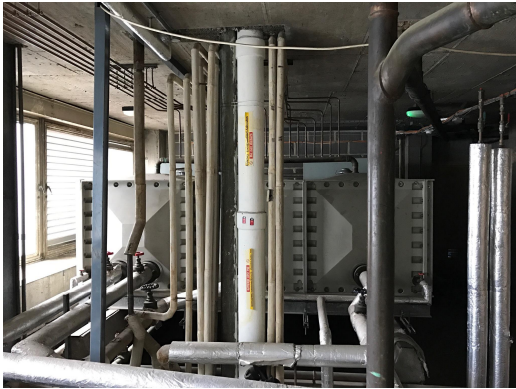
Photo 23: Cement pipe within seventh floor tank room

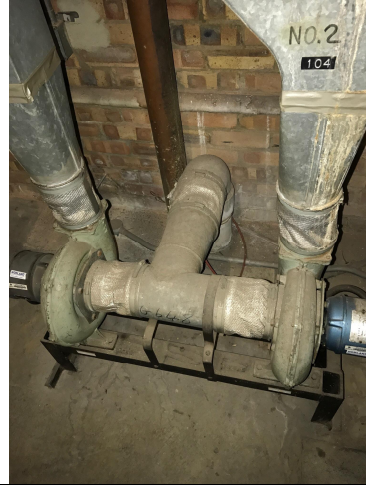
Photo 24: Gaskets to hot pipework

4. Where gaskets to pipework are not easily identifiable as non-asbestos (e.g. rubber, aluminium, thermoplastic or cork) they should be presumed to contain asbestos until sampling can be carried out by a qualified person.

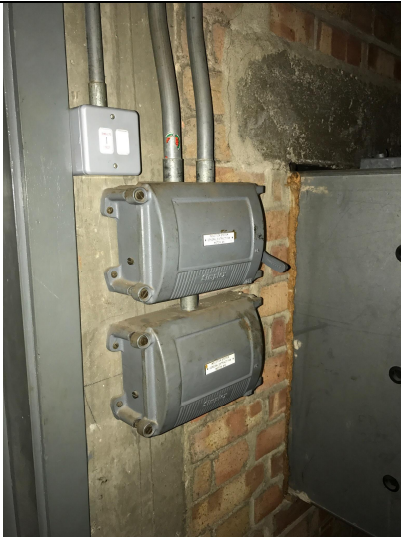
Photo 25: Non-accessed electrical units

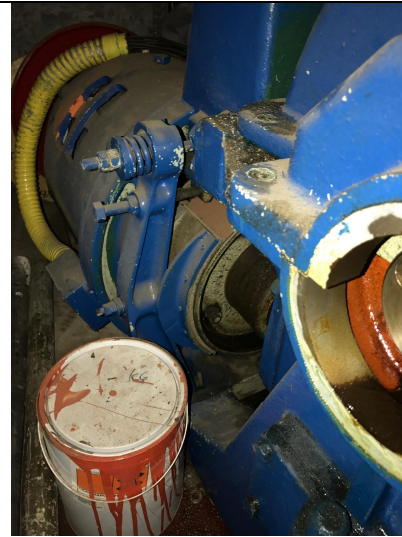
Photo 26: Brake shoes to redundant lift motor

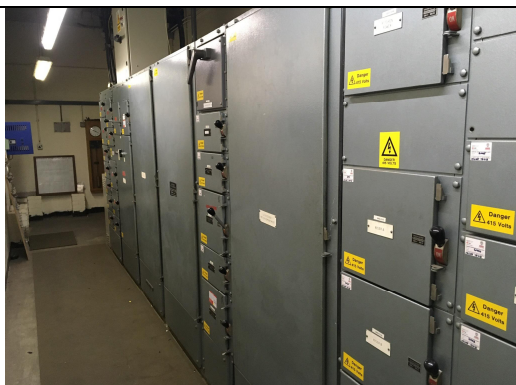
Photo 27: Non-accessed electrical units

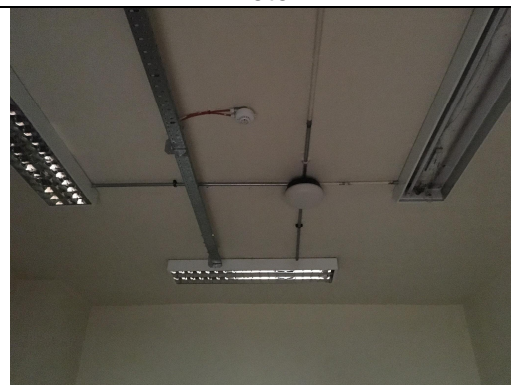
Photo 28: Textured coating to ceiling and walls

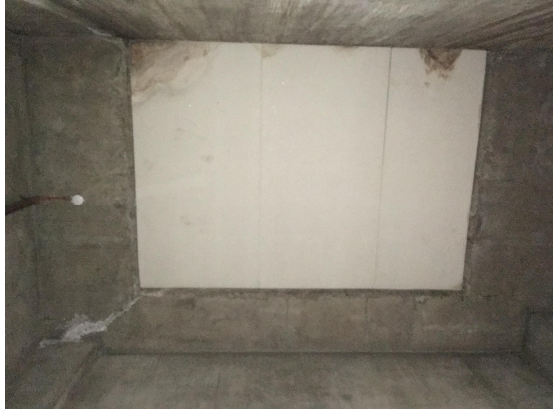
1. There is evidence that the spray coating in Plant Room 1 (Basement) has been removed, as the area is now covered by a non-asbestos panelling, but paperwork concerning any works was not evident at the time of the survey. For this reason, it should be presumed that the insulation still exists above the panelling until such time as further, intrusive investigation can be made or the paperwork can be located. Also note that there may be sprayed coating elsewhere within the building within inaccessible areas that may require destructive access to locate.

Photo 29: Basement Boiler House ceiling, non-asbestos insulating board (with possible sprayed coating behind)

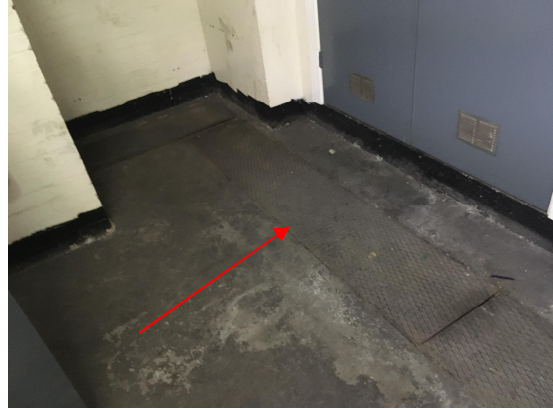
Photo 30: Basement lobby (area 15), non-accessed floor ducts

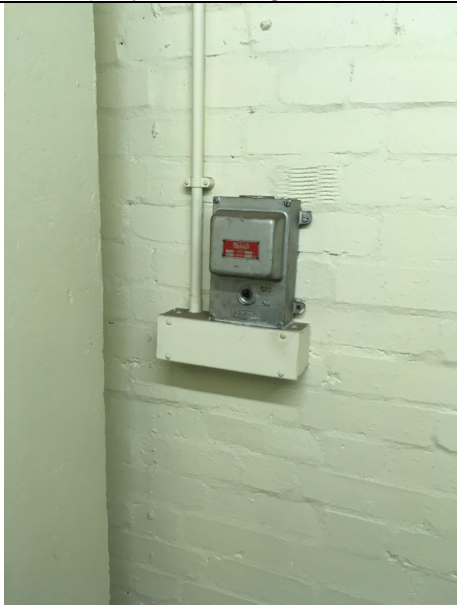
Photo 31: Basement corridor, non-accessed live electrical unit
