Preliminary bat roost assessment

Client Name	JLL Limited
Site Location	Banbury magistrates court, The Court House, Warwick Rd, Banbury OX16 2AW
Document reference	CE1167-01
Date of Survey	16th August 2018
Surveyed by	Scott Lataham [Class 2 registration Accreditation 2017-28032-CLS-CLS]

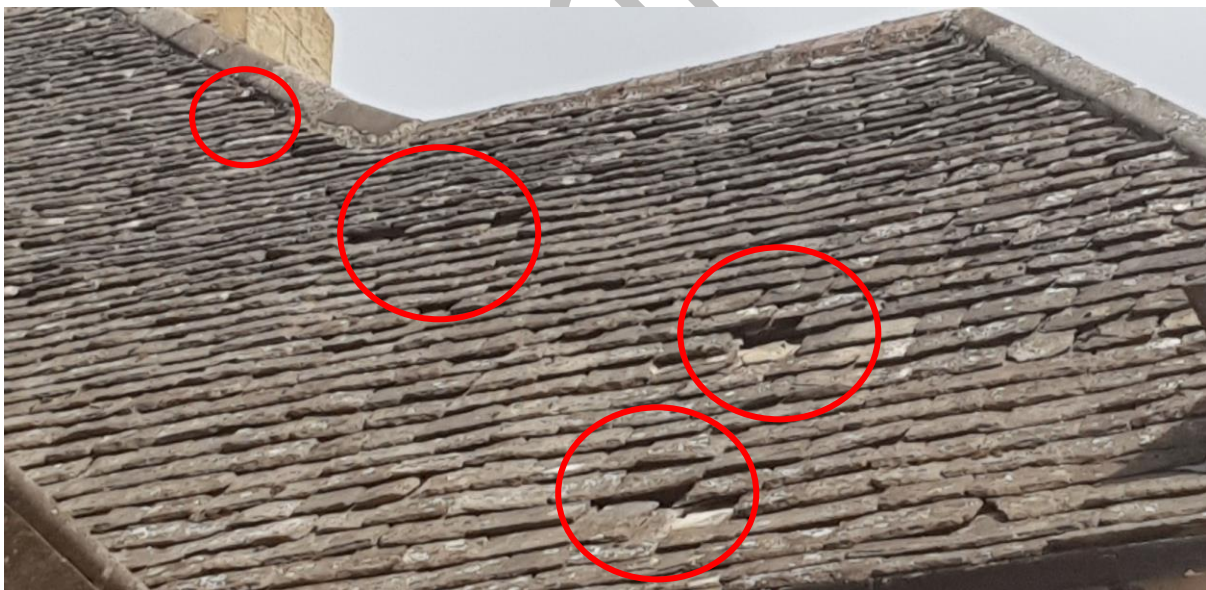
- Gaps within and below several ridge tiles were visible which offer roosting value to crevice dwelling species along with possible access within the internal roof void for void dwelling species.
- The style & age of tiles used for the main roof coverings below the ridge have demonstrated further areas of value to both crevice and void dwelling bats from the high number of gaps throughout.
- A number of flat roof coverings to the rear of the building were not accessible and restricted from assessment

Image 2 – Areas of deterioration to the roof coverings (South facing) have been identified to include missing tiles and gaps to the ridge tiles which offer roosting value to bats

Dependant on the level of activity a European Protected Species mitigation licence may be required to maintain protection of any protected species identified during development.
- 6.5** No evidence of nesting birds identified.
- 6.6** It is advised that no further works take place to the identified areas of value to bats at this stage as this may cause disturbance to any roosting bats, see section 2.0 of this report

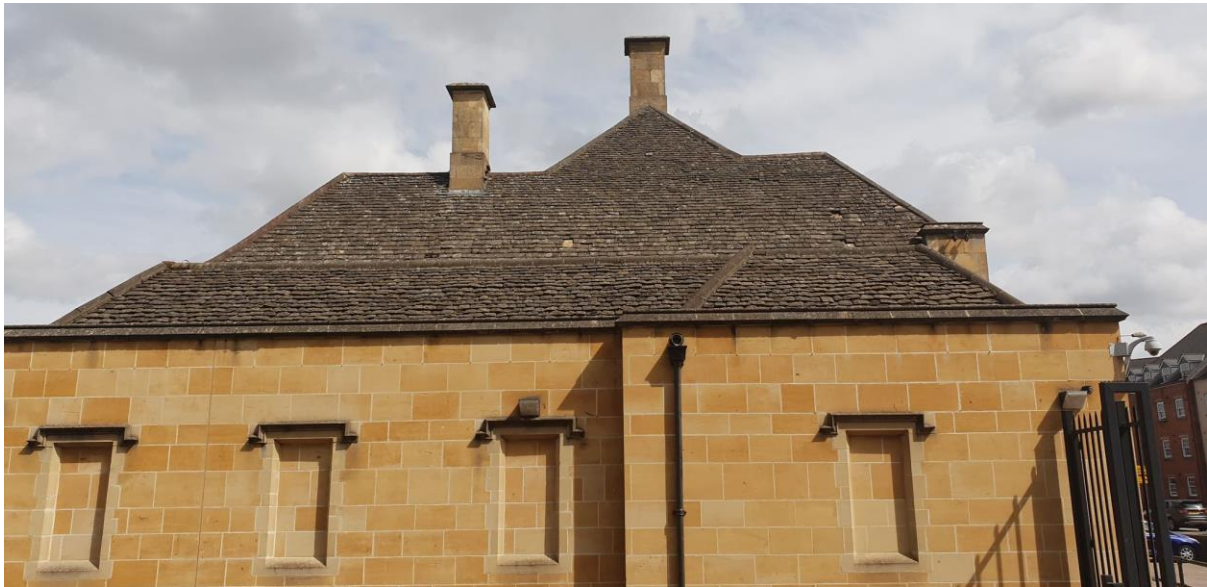
Image 3 – West facing elevation of the building where multiple gaps are identified across the roof coverings offering further value to bats throughout due to the age and style of the tile used

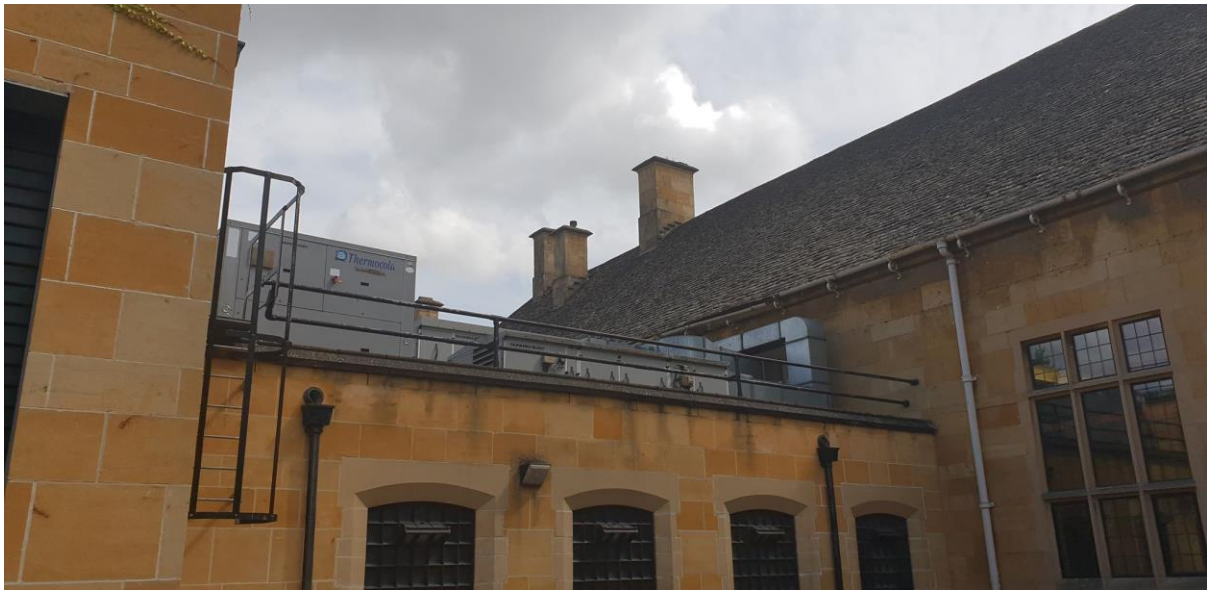
The stonework's around the building demonstrated a well-maintained level of condition with low value to bats identified. However, due to the height and shape of the building we were obstructed from a number of areas to the rear of the building where assessment was restricted.

Image 5 – Further image of the North facing elevation of the building demonstrating a well-maintained level of stonework's offering low value to bats

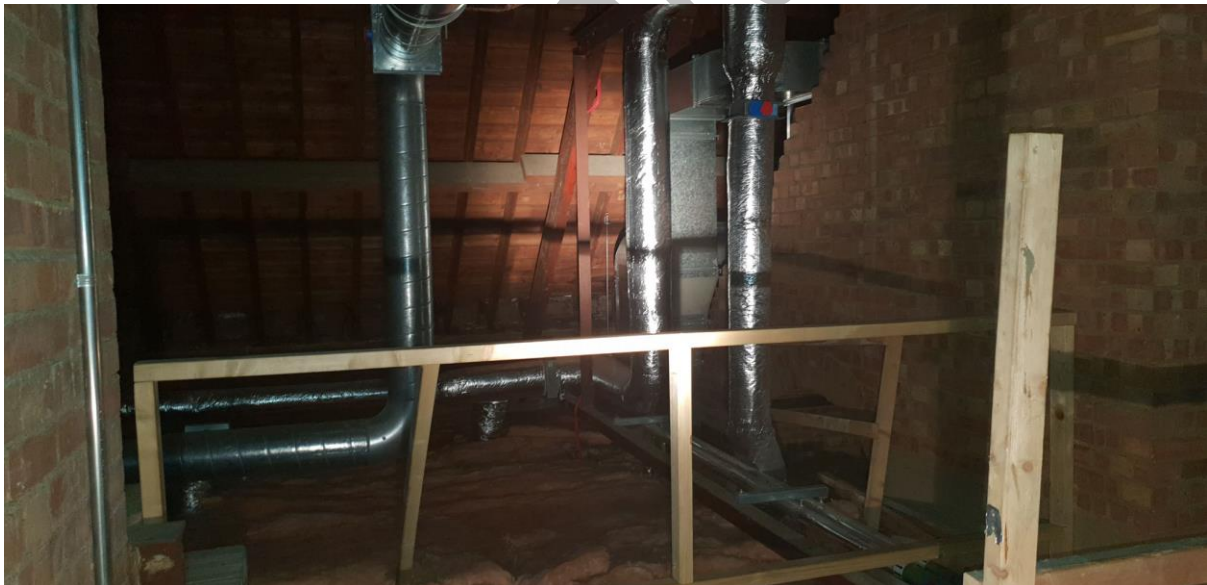
4.7 Internally the floor areas to the roof void were covered with an insulated covering and part timber board throughout.

Below the roof coverings is a timber cladded covering which has restricted visibility or access into areas of value to bats identified externally.

Image 6 – Internal view from central area of roof void demonstrating a timber cladding below the tiled coverings along with an insulated covering to the floor area

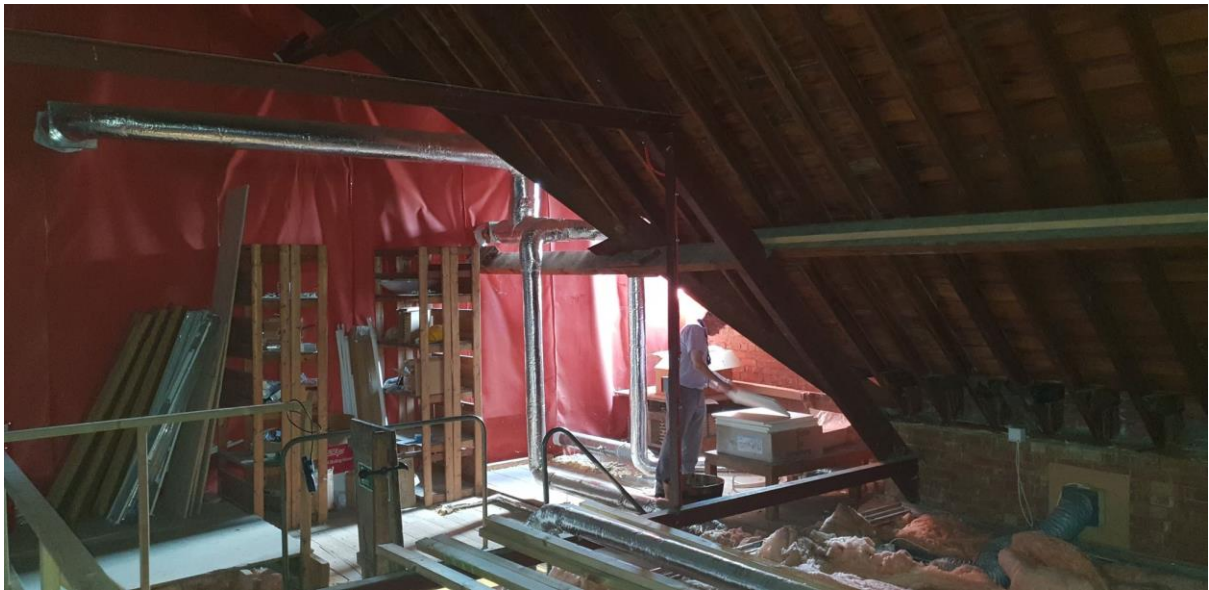
The internal areas of the roof void house several air-conditioning pipework's and systems.

Image 7 – Further views from within the roof void demonstrating the air-conditioning pipework's running within the void areas along with plastic sheetings

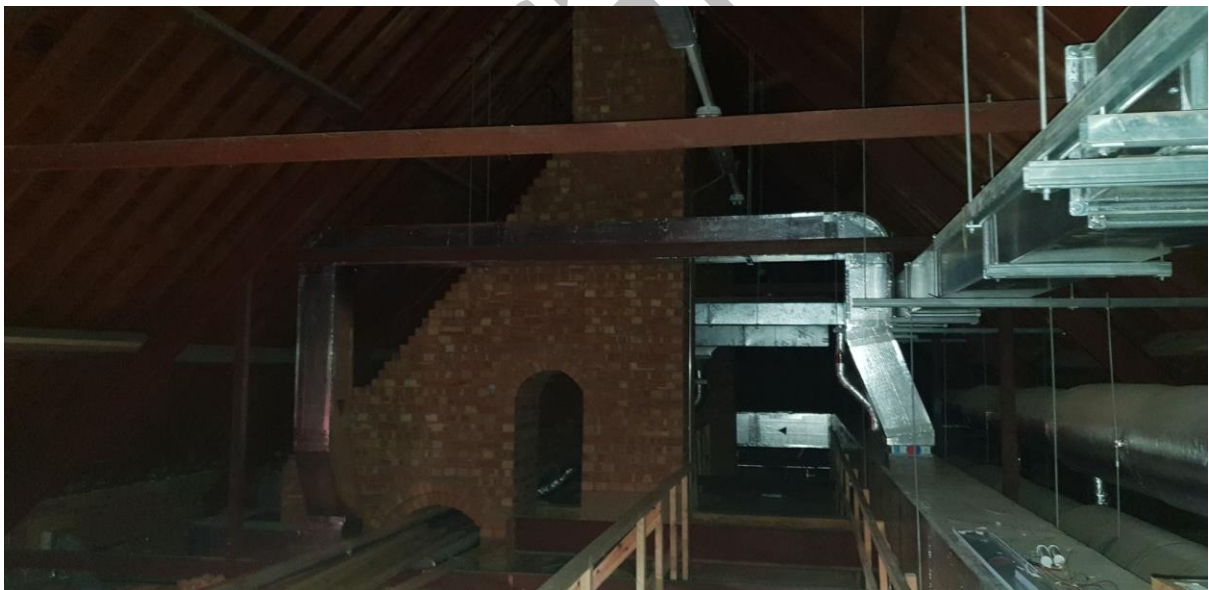
Image 8 – Internal section within the main roof void demonstrating the chimney sections running within which looked to be in a well maintained condition with low value to roosting

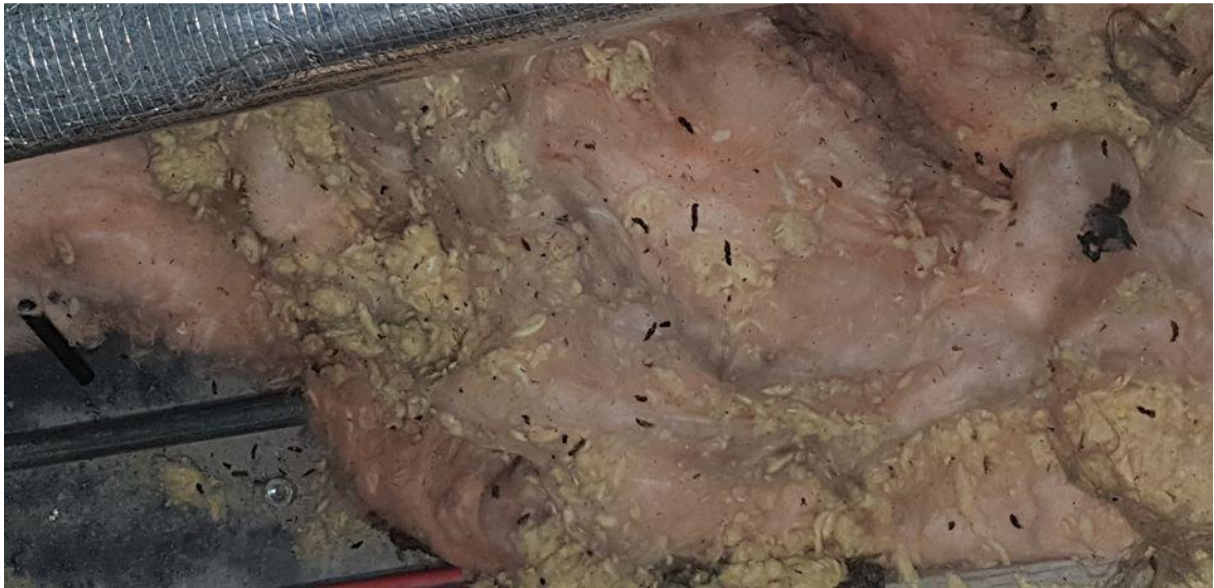
Several bat droppings have been noted within the main roof void space which has demonstrated roosting within.

Image 9 – Bat droppings located within the main roof void across the insulation

- 6.1** Following the preliminary bat roost assessment carried out on the 16th August 2018 it has been identified that the building offers suitable features of value to bats within the roof coverings and internal voids.
- 6.2** It has been evidenced that Bats have used features within the building from observation of several bat droppings within the main roof void area which have been documented within this report.
- 6.3** Records have demonstrated two EPS Mitigation Licences for 4 species of Bats within a 2km radius of the site along with favourable habitats for both feeding & commuting.
- 6.4** It is advised that if development is to cause any disturbance to the current roof coverings, eaves, flat roof sections and roof voids a further three emergence surveys would be required to fully assess all features of value along with areas un accessible on the 16th August.

Emergence surveys must be carried out within May – September with at least one survey between May – August.
