## Enfield Magistrates Court Re-inspection Survey Asbestos Report

November 2015

**Project No:** S-207776

**Address of Site:** The Court House, 71 Lordship Lane, Tottenham, Greater London, E11 1QW

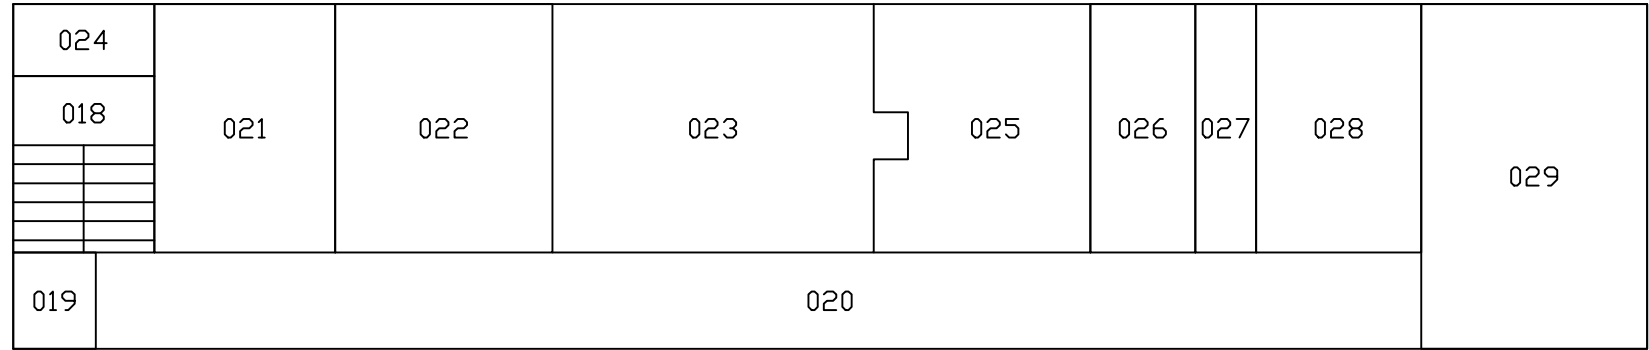
Project No.	S-207776
Building	Enfield Magistrates Court
Floor	First
Page	3 of 4
Drawn By	LAB
Issue	1

FRONT

REAR

This is a floor plan diagram, **NOT TO SCALE**.  
**ALL SECTIONS OF THE REPORT MUST BE READ IN CONJUNCTION WITH THIS FLOOR PLAN.**  
**CAVEATS APPLY.**

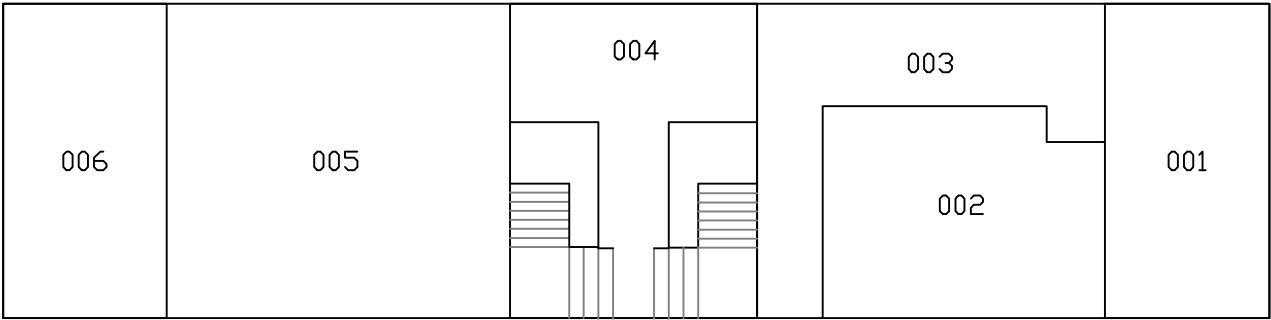
Project No.	S-207776
Building	Enfield Magistrates Court
Floor	Second
Page	4 of 4
Drawn By	LAB
Issue	1

This is a floor plan diagram, **NOT TO SCALE**.  
**ALL SECTIONS OF THE REPORT MUST BE READ IN CONJUNCTION WITH THIS FLOOR PLAN.**  
**CAVEATS APPLY.** VI.5
